NIST NCSTAR 1-5A

**Federal Building and Fire Safety Investigation of
the World Trade Center Disaster**

Visual Evidence, Damage Estimates, And Timeline Analysis

William M. Pitts
Kathryn M. Butler
Valentine Junker

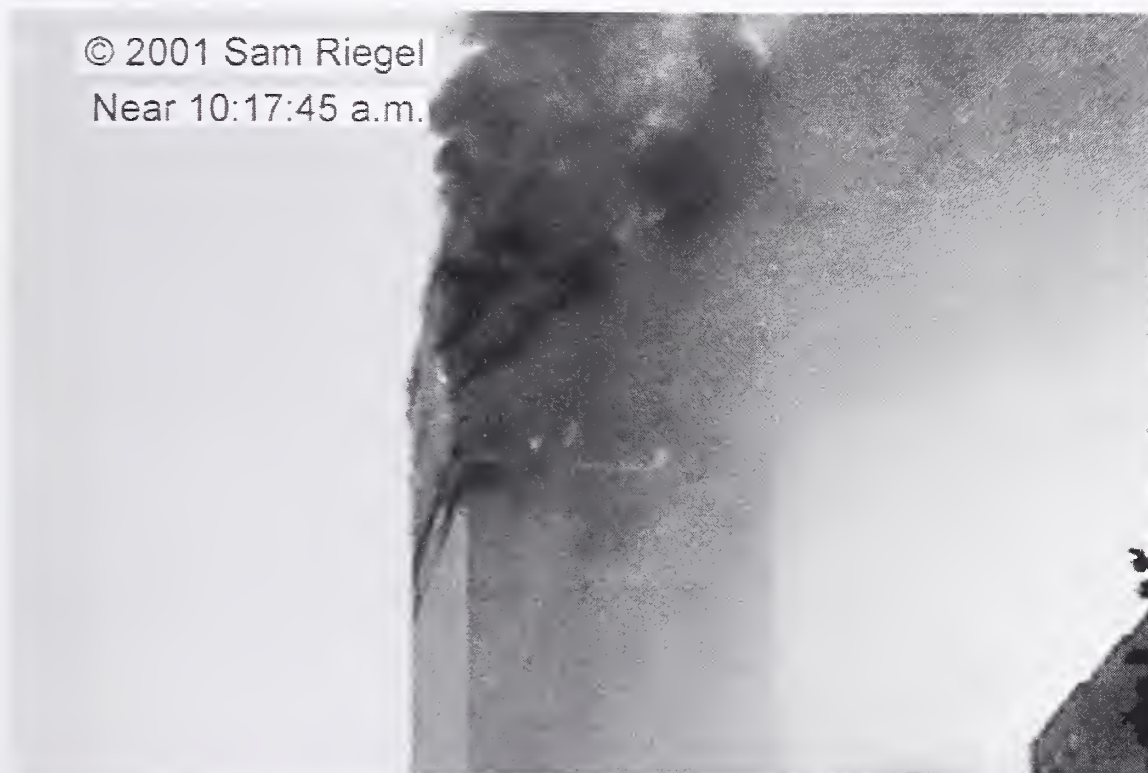
The line of fire on the 98th floor is still quite distinct. There is an intense external flame on the eastern side of this fire located at a point to the east of the center of the face. This fire appears to be moving toward the east. Two tongues of flame are evident coming from the floor above, i.e., the 99th floor, near the center of the western half of the south face. The video shows that the entire region between the two tongues of external flames is involved. The fire on the 97th floor on the eastern side of the face is just barely visible. Flames are not visible on the 96th floor. The smoke plume coming from windows lower down near the center of the face is also visible. Even though individual floors are not resolved in this image, the location of the smoke relative to other details indicates that it is indeed coming from the 92nd floor.

While limited, the visual information available indicates that fire had spread into areas on the east side of the south face of WTC 1 during this time period. A major fire has also grown on the 99th floor on the western side of the face.

Figure 8-88. This image shows the south face of WTC 1. It was captured from a video shot from the ground and has been enhanced by adjusting the intensity levels. The estimated time of 10:17:45 a.m. is based on a comparison of the fire distribution with a video recorded from a news helicopter and could be off by as much as a few minutes.

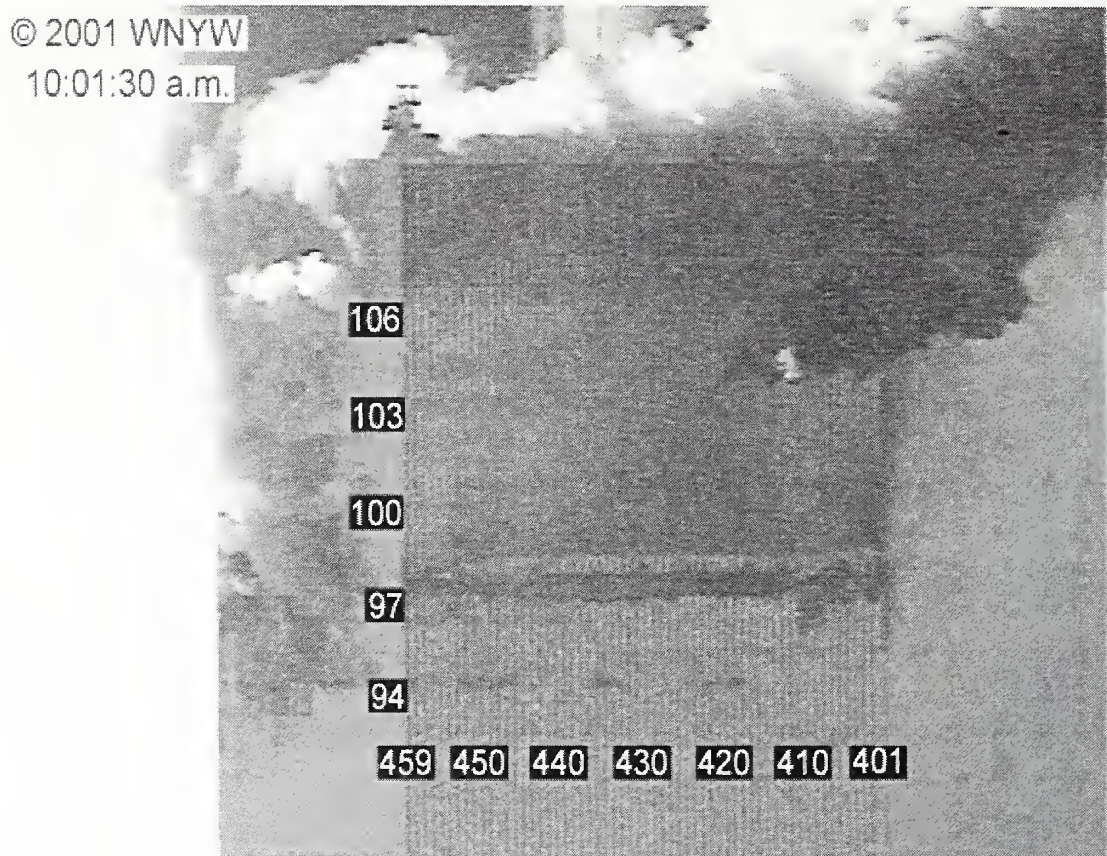
Figure 8-89 shows an image of the west face shot from a news helicopter at 10:01:30 a.m. The flames on the 104th floor are coming from several windows centered near window 104-411. Heavy black smoke is venting from multiple windows over a much larger area. It is informative to compare the appearance of the smoke in Figure 8-89 with that in Figure 8-74, which shows the west face at 9:56:10 a.m. The smoke has clearly become much heavier and darker.

Figure 8-89. This image of the north and west faces of WTC 1 is a frame captured from a video recorded by a news helicopter at 10:01:30 a.m. The image has been enhanced by adjusting the intensity range, and some areas are saturated. Column and floor numbers have been added.

The deep orange glow along the 98th floor in Figure 8–89 indicates that the interior fire on this floor is continuing to burn along much of the length of the west face. The fire on this floor has moved north since around 9:58 a.m. Flames can now be seen as far as window 98-455. The floor plan layout shown in Figure B-7 indicates that there were two rooms along the west face in the northwest corner of the 98th floor. Fire has entered the southernmost of these rooms, which had interior walls at columns 98-452 and 98-456. There is as yet no visual evidence for fire on the west side of the corner room with walls at columns 98-456 and 98-108.

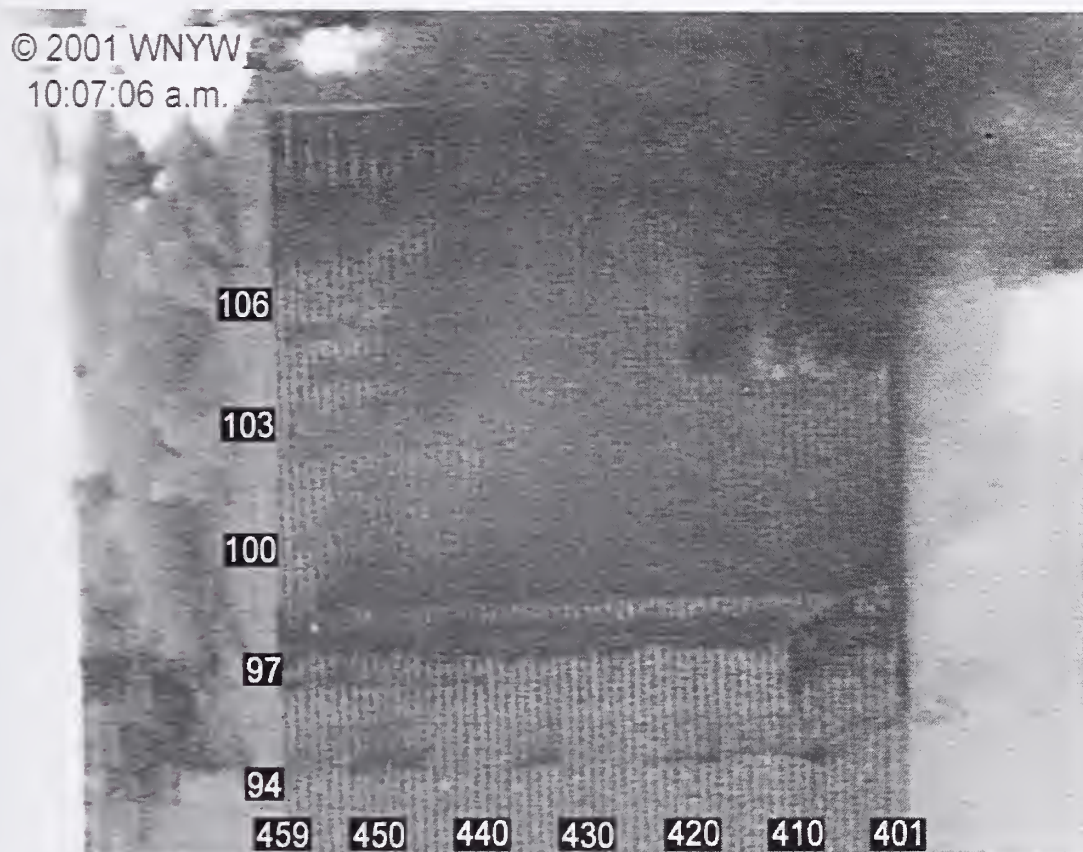
Another view of the west face taken from a video shot from one of the news helicopters at 10:07:06 a.m. is shown in Figure 8–90. The fire on the 104th floor is still raging, with flames coming from windows 104-404 to 104-414. On the 98th floor the deep orange glow from the internal fire is still present along nearly the entire length. A small flame extends from window 98-455, but the fire does not yet appear to have moved into the room on the northwest corner. On the 94th floor the most intense fire is observed in windows 94-412 to 94-414. Smoke is also evident coming from window 94-408. This smoke had appeared abruptly six seconds earlier.

Figure 8-90. This image of the north and west faces of WTC 1 is a frame captured from a video recorded by a news helicopter at 10:07:06 a.m. The image has been enhanced by adjusting the intensity range, and some areas are saturated. Column and floor numbers have been added.

In Figure 8–90 there is no visual indication of fire on the west side of the 95th floor. However, the summary of observations of falling people in Appendix M provides evidence that fires were moving into the area. At 10:06:11 a.m. a person fell from the west side of the 95th floor. During the next minute and forty-five seconds 12 more people fell from the same floor. For some of these people, the windows that they fell from have been identified. They ranged from window 95-424 to window 95-428. These windows were closed at 9:40:14 a.m. as seen in Figure 8–70.

A video recorded at 10:06:56 a.m. with similar detail as Figure 8-90 had a very similar appearance, i.e., there was no indication of a fire on the 95th floor. At this point the video zoomed out, and it was no longer possible to see details of the floors. By the time the video zoomed back in on the building at 10:08:11 a.m. interior flames were visible inside numerous windows on the 95th floor.

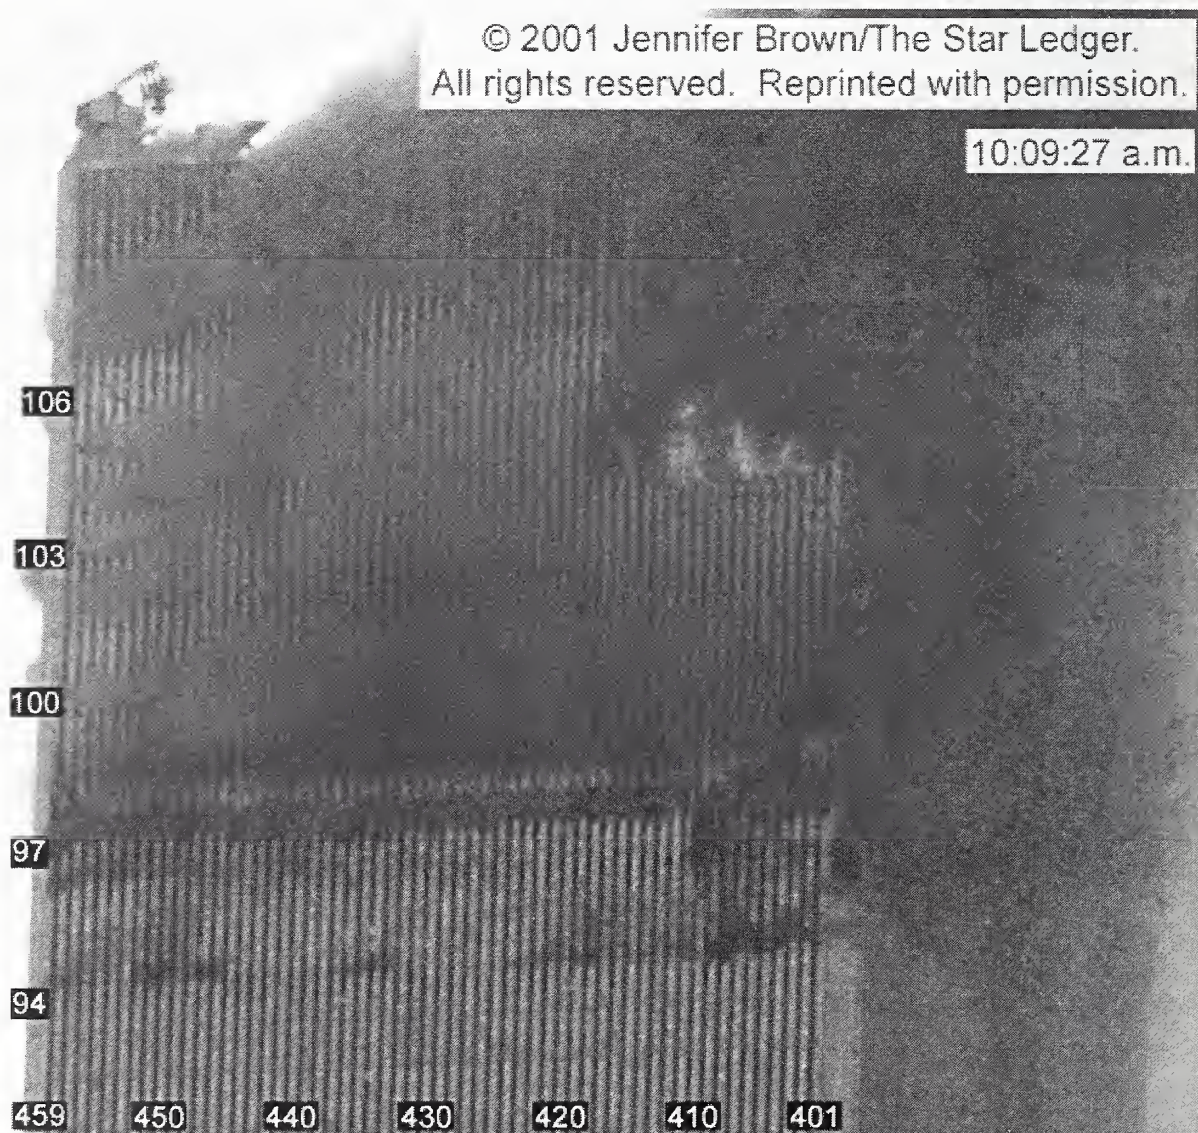
Figure 8-91 shows a photograph of the west face recorded shortly afterward at 10:09:27 a.m. Flames are visible on the 95th floor in windows 95-430 to 95-447. A video of the west face indicates that fire was present as far south as window 95-425 by 10:10:10 a.m. The images indicate that an extensive fire that had not been visible three minutes earlier appeared over a large length of the west side of the 95th floor.

Figure 8-91. This photograph, showing the west face of WTC 1 and an oblique view of the south face, was recorded at 10:09:27 a.m. The image has been cropped and enhanced by adjusting intensity levels. Column and floor numbers have been added.

At some point between 10:07:12 a.m. and 10:07:55 a.m., smoke began coming from the west windows in the room at the northwest corner of the 98th floor. In Figure 8-91 a flame is evident in window 98-458 at 10:09:27 a.m. This flame was not evident in a lower resolution video of the area taken at the same time, but flames did become visible in windows 98-456 to 98-458 starting around 10:10 a.m., with some flame extension from windows apparent. Recall that heavy smoke and flames appeared from the north windows inside this room starting at 10:10:15 a.m. The opening of so many windows in such a short period indicates that flashover took place in this room around this time. The flames coming from the west windows are visible in Figure 8-83, taken at 10:11:41 a.m.

The orange glow seen in Figure 8-91 over much of the 98th floor indicates that the interior fire present on this floor continued to burn at this time. By entering the room on the northeast corner around 10:10 a.m., this fire had completed its spread across the entire west side of the floor. Recall that the fire had entered the adjacent room with walls at columns 98-252 and 98-256 (see Figure B-7) around 10:00 a.m.

Small areas of isolated flames can be seen in several windows on the 94th floor in Figure 8-91. There appears to be a somewhat larger fire present at window 94-408 and windows immediately to the north. The smoke stream that appeared at 10:07:00 a.m. from window 94-408 is still apparent. Windows to the south appear to be intact. The fact that the fire did not appear to move south in the nearly 150 s period between these images is somewhat surprising because the floor plan layout (see Figure B-3) indicates that the fire was burning in a room with walls at columns 94-405 and 94-417. The fire might have been expected to spread to the southern wall of this room. Videos shot from the west indicate that the stream of smoke coming from window 94-408 was present until the end of the current period at 10:18 a.m.

Figure 8-91 provides a good view of the fire on the 104th floor of the west face. Flames continue to come from the open windows, and fire is evident from window 104-403 to window 104-416.

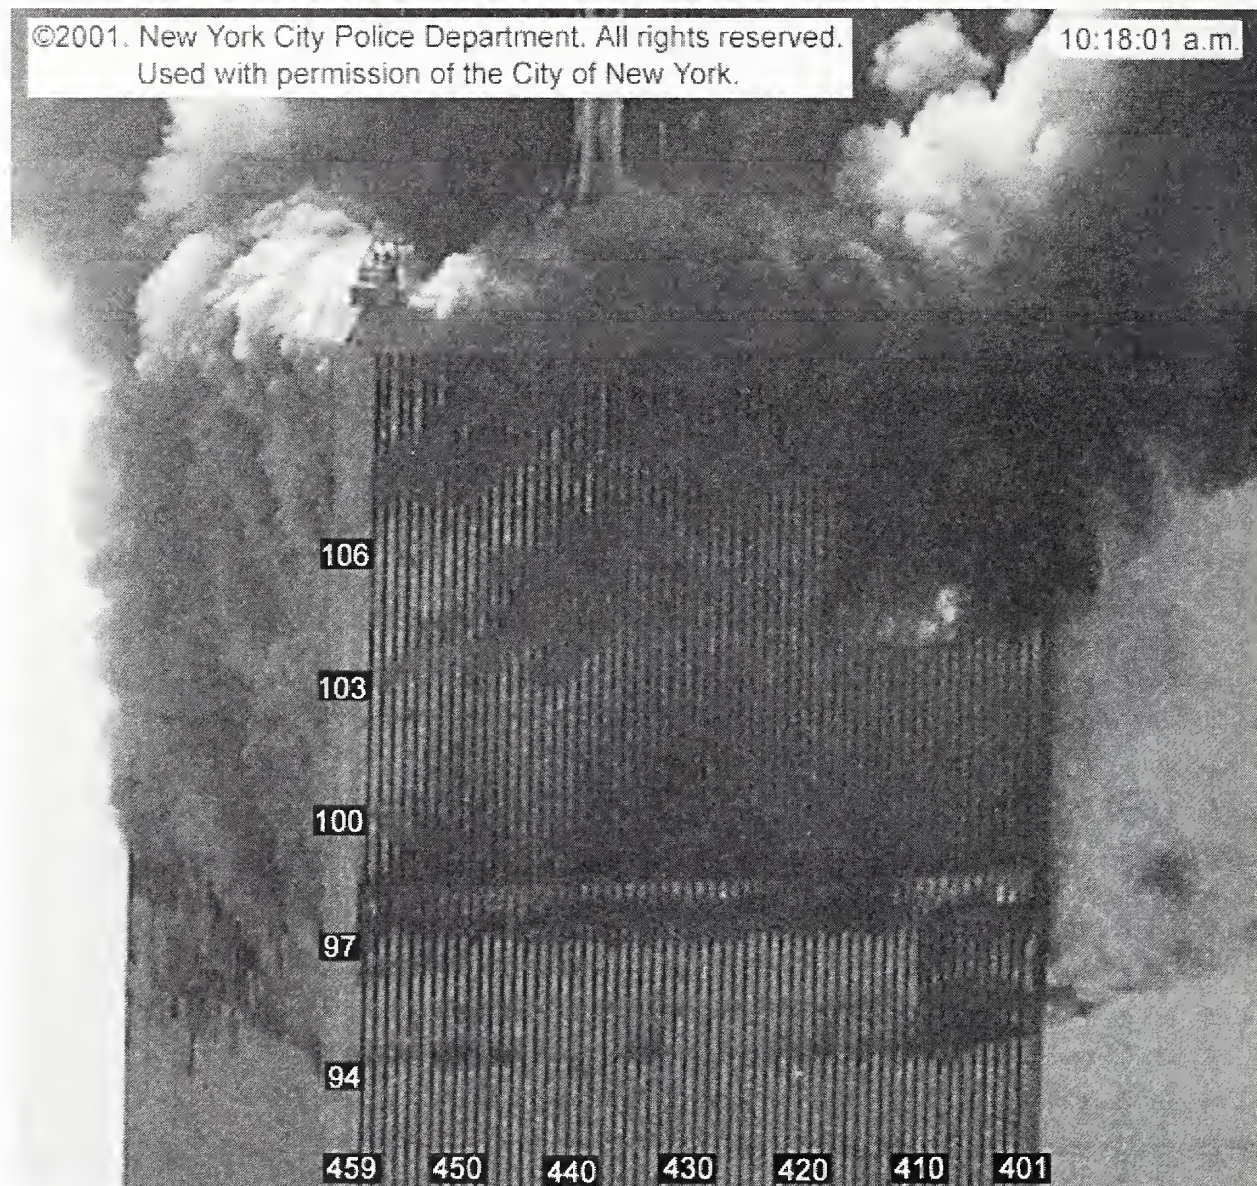
Figure 8-92 shows an image of the west face of WTC 1 recorded at the end of the current time period at 10:18:01 a.m. With a few exceptions, the appearance is similar to that seen around 10:10 a.m. The fire on the 95th floor has spread in both directions across the face. Low intensity flames can be seen in windows over a length from window 95-413 to window 95-455. Even though the fire extends over a long length of the face, there is very little smoke, and there are no flames coming from the windows on this

floor. The absence of significant smoke marks on the column covers near the tops of the windows is consistent with these observations. Based on the floor plan layout shown in Figure B-4, the fire on this floor has penetrated the room with walls at columns 95-452 and 95-456, but there is no indication that it is yet inside the room on the northwest corner with walls at columns 95-456 and 95-108.

Figure 8-92. This cropped photograph of the west face of WTC 1 and an oblique view of the north face was shot at 10:18:01 a.m. The image was enhanced by adjusting the intensity levels, and column and floor numbers have been added.

Relatively small fires are observed at several locations on the 94th floor. Heavy smoke continues to come from window 94-108. In fact, heavy smoke and fire are apparent at windows 94-108 and 94-109. The fire on the 98th floor can still be seen across most of the west face, and it is still primarily an interior fire. Heavy smoke and flames continue to come from the fire on the 104th floor. The location of this fire appears to be the same as at 10:10 a.m.

From the angle from which Figure 8-112 was taken the internal fires on the 98th floor are only visible near the center of the floor and at a few locations on either end. This fire has clearly died down considerably since Figure 8-92 was taken at 10:18:01 a.m. Carets are visible at the tops of the column covers near the two ends, but very little marking is evident elsewhere. This suggests that the only places flames came out of windows were from fires burning inside the corner rooms (see Figure B-7). Consistent with earlier observations, the absence of column cover marks elsewhere indicates that neither fire nor smoke flowed from most 98th floor windows on the west face where fire was present.

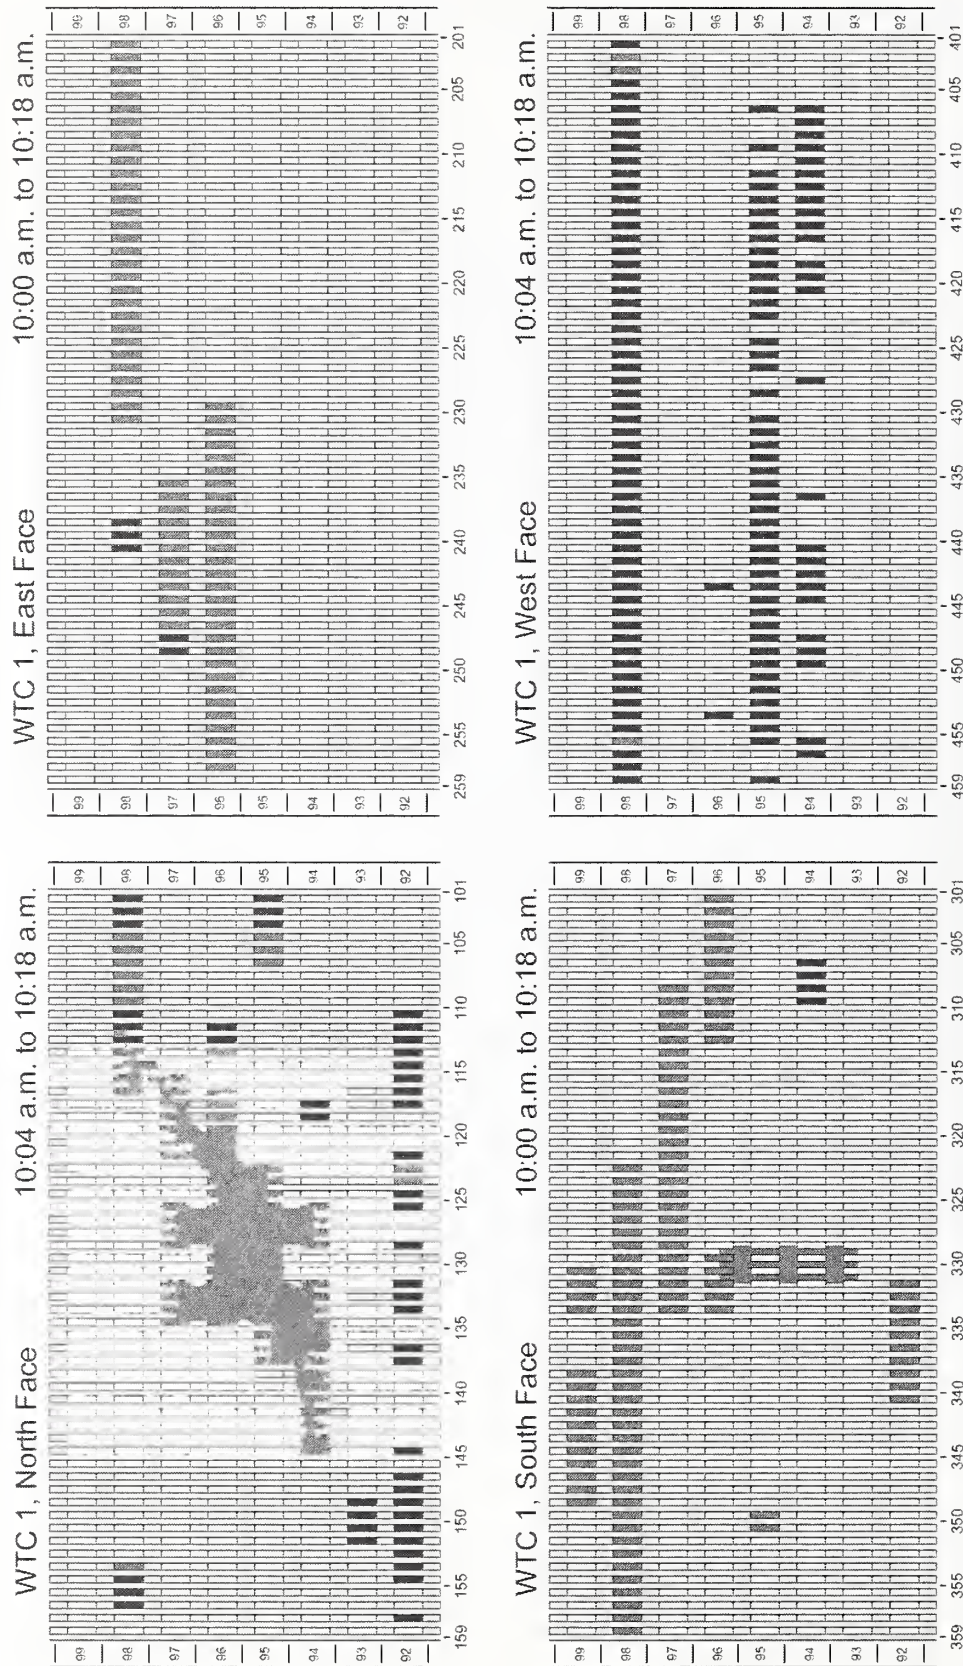
The most prominent feature of the fire growth on the west face was the appearance (not included in Figure 8–93) of an intense fire with extended flames on the 104th floor shortly after the collapse of WTC 2. This fire continued to burn intensely during the entire period. The fire on the 98th floor continued moving toward the north, reaching the north face during the period. A relatively low-intensity fire appeared on the 95th floor and subsequently covered a large fraction of the floor across the face. The fire burning on the 94th floor continued to spread toward the south early in the period, but then seemed to halt near window 94-108 for several minutes.

Figure 8-93. Maps of integrated fire observations between 10:00 a.m. and 10:18 a.m. are shown for the four faces of WTC 1. Colors represent the highest intensity fire observed in a window using the color scale defined in Figure 5-1.

The results of integrating the fire data sheets for the period between 10:18 a.m. and 10:28 a.m. are shown in Figure 8-115. The same cautions apply as for the analogous data shown in Figure 8-93. In particular, data for the east and south faces should be considered approximate due to the quality of imagery for these faces during the period.

Comparison of Figure 8-93 and Figure 8-115 shows that during the final time period prior to the collapse of WTC 1, intense fires grew in or spread to several locations, including the western half of the north side of the 92nd floor, the southern half of the east side of the 98th floor, and the eastern halves of the south sides of the 98th and 99th floors.

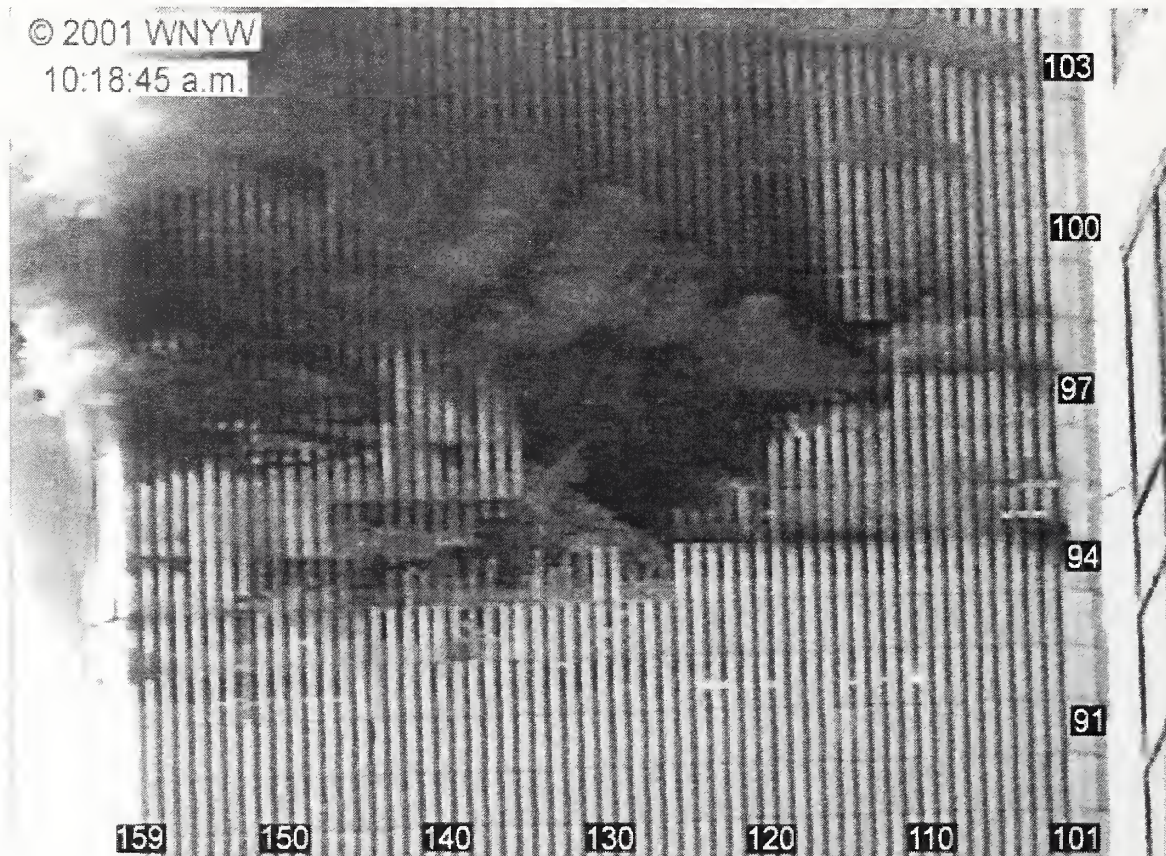
Figure 8–94 provides a view of the north face of WTC 1 at 10:18:45 a.m. Comparison with Figure 8–84 shows that, during the just over three and a half minutes between the images, the fire on the 92nd floor continued to move toward the west. In the later image fire is visible as far west as window 92-110. At the earlier time windows to the west of window 92-120 appeared to be intact, with fire present in window 92-121. Despite the presence of flames over a significant length of the floor, the fires appear to be burning at low levels at separated locations. There is essentially no smoke coming from the open windows on the north side of the floor. This indicates that the smoke is likely venting elsewhere.

Figure 8-94. This image of the north face of WTC 1 was captured from a video shot at 10:18:45 a.m. It has been enhanced by adjusting the intensity range. Some portions of the image to the left of the tower are saturated. Column and floor numbers have been added.

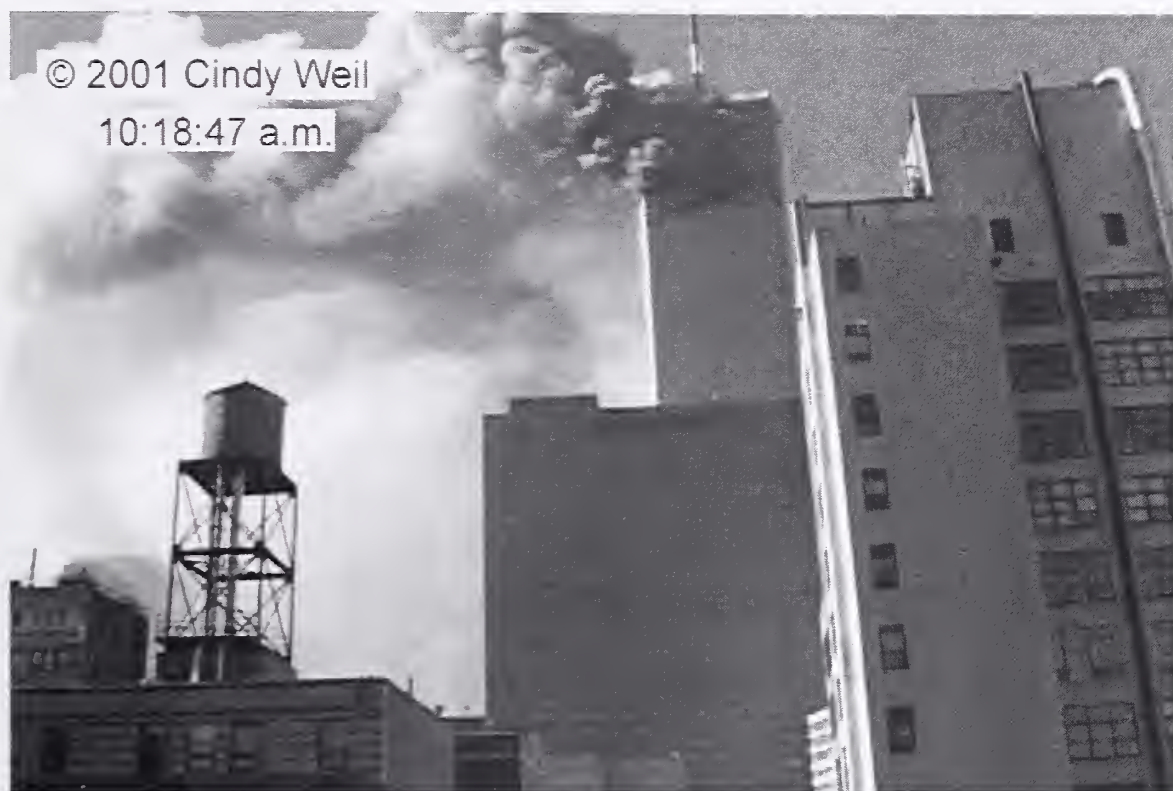
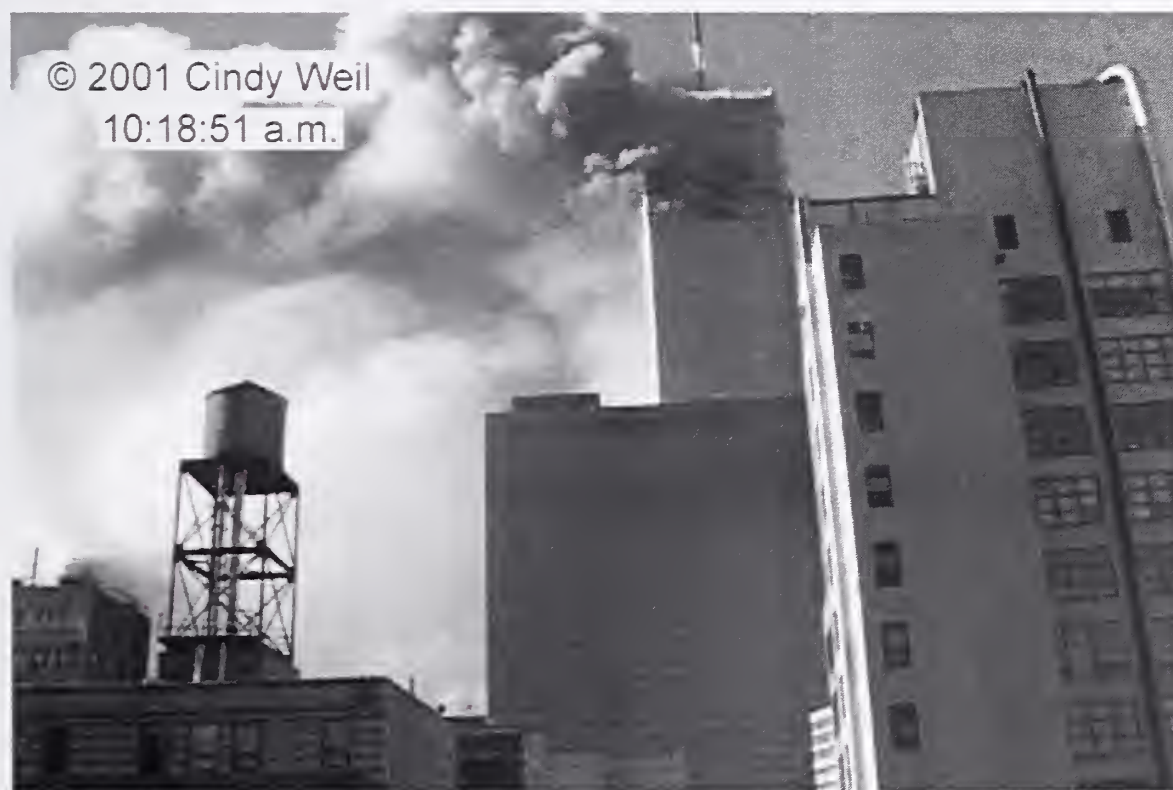
At 10:18:48 a.m. an event took place within the tower that created a pressure pulse of sufficient magnitude to force smoke out of numerous windows on the north face, as well as from the other faces. The most obvious effect of this pressure pulse was the release of a dense line of smoke along a length of the 92nd floor on the north face, extending from roughly window 94-110 to window 94-139. This smoke release was evident in numerous videos, including a number shot at great distances. Figure 8–95 compares two frames taken from a video showing the north face just prior to the smoke release and the appearance just over 4 s later. Even though the video was shot from a distance, the line of smoke that has appeared from the 92nd floor is readily apparent. It is significant that until this time very little smoke had been observed coming from the open windows on this floor, even though fires had been burning on the floor for some time.

Closer inspection of this video, as well as others, shows many additional effects of the pressure pulse at other locations on the tower. Smoke and/or dust were pushed out of windows on the east side of the north face at the 94th floor. This material is responsible for the light-colored “smoke” seen near the eastern edge of the building immediately above the darker smoke released from the 92nd floor in Figure 8–95.

On the western side of the north face there is a region of increased smoke flow higher up in the vicinity of the 95th to 98th floors. While it is difficult to see in the frame recorded at 10:18:51 a.m., it is clear in the video that a large flame was pushed out of windows on the 95th floor by the pressure pulse. Comparison of the two frames shows that smoke is present on the west face in this same area at the later time, which was not apparent earlier.

Figure 8-95. Two images of the north face of WTC 1 captured from a video are shown. The times are 10:18:47 a.m. and 10:18:51 a.m.

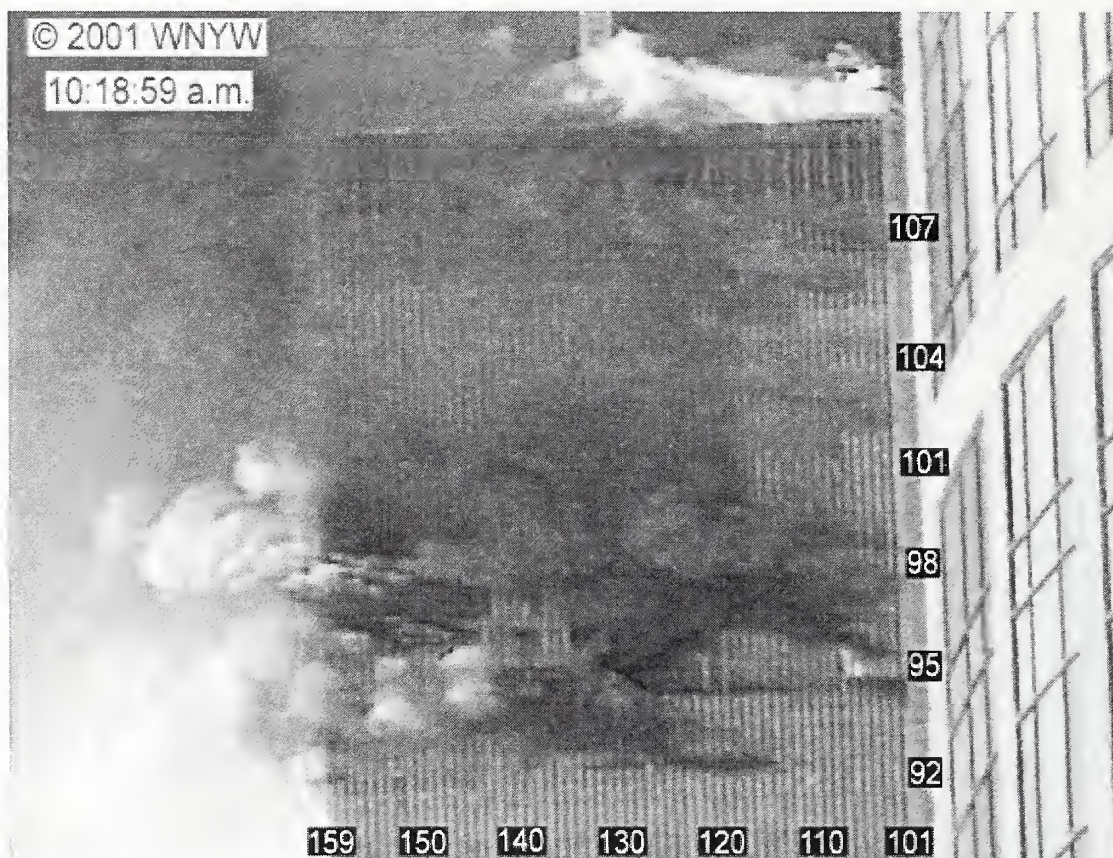
Figure 8-96 shows a closer view of the north face recorded at 10:18:59 a.m. This image is taken from the same video as Figure 8-94, which was recorded 14 s earlier. The effects of the changes in the smoke and fire described above are easily seen. The black line at the tops of the column covers on the 92nd floor created by the smoke release is visible. The fire on the western edge of the 95th floor has grown dramatically, and flames now extend from windows 95-105 and 95-106. Heavy smoke is now coming from windows on the 95th floor as well as windows at the western edge of the face on the 96th and 97th floors. Smoke is also now flowing from window 102-101 on the 102nd floor.

Figure 8-96. This image of the north face of WTC 1 was captured from a video shot at 10:18:59 a.m. It has been enhanced by adjusting the intensity range. Column and floor numbers have been added.

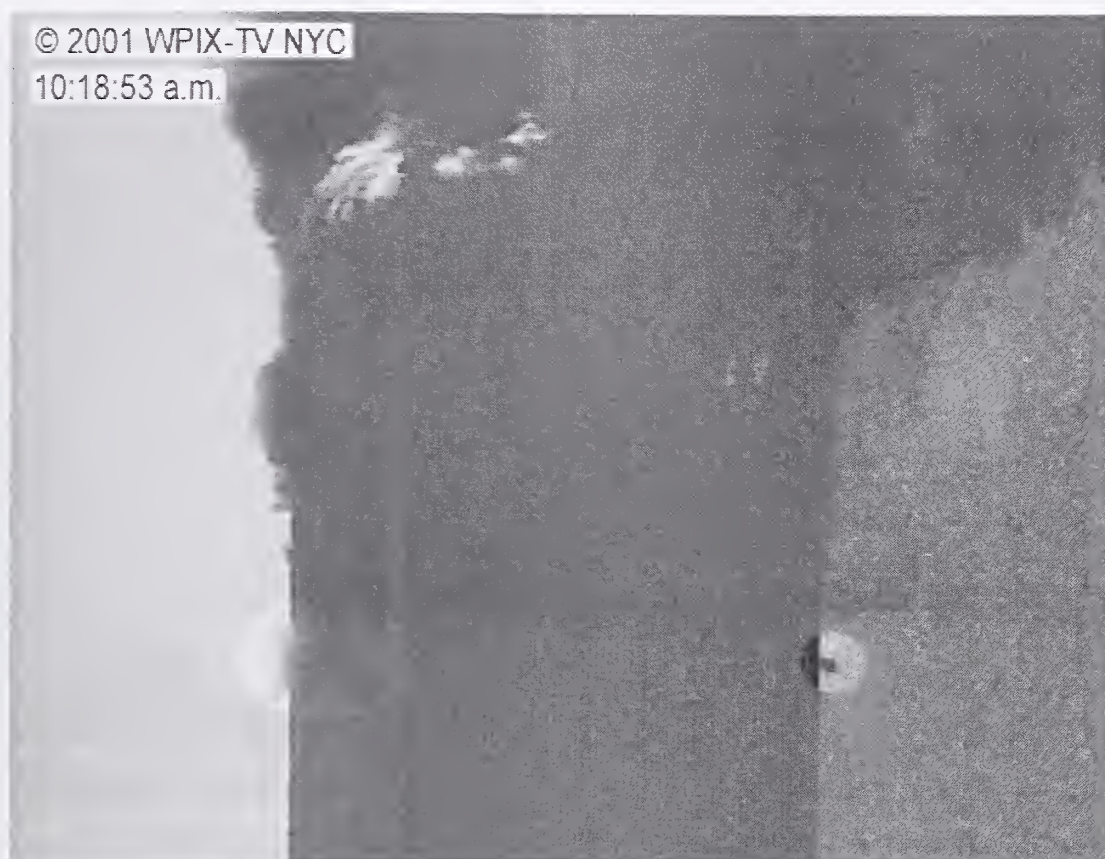
A video shot from the west shows that heavy smoke was pushed out of windows on the 95th and 98th floors on the north side of the west face at the same time the changes were observed on the north face. This video also shows what appears to be a jet of smoke being ejected from a lower floor on the south face of the tower. A view of this jet is highlighted in Figure 8-97, which shows a frame taken from the video 5 s after the start of the pressure pulse, i.e., at 10:18:53 a.m. The smoke coming from the 92nd floor on the north face is also highlighted. The video also shows a large amount of debris falling along the north and south faces of the tower around the time of the pressure pulse.

The fact that smoke and fire were pushed out of the tower from numerous windows over multiple floors confirms that a significant pressure pulse was generated inside the building. Similar behaviors were observed when the second plane impacted WTC 2 and when WTC 2 collapsed. While it seems likely that the pressure pulse was generated by some sort of collapse within the tower, e.g., a portion of the core settling or a partial floor collapse, it has not been possible to determine the nature of the event or even its general location based on the visual record.

Figure 8-97. This image showing the west face and an oblique view of the north face was captured from a video shot from a news helicopter at 10:18:53 a.m. The highlighted areas with adjusted intensities indicate smoke and dust plumes that were pushed from the north and south faces by a pressure pulse that passed through the tower at 10:18:48 a.m.

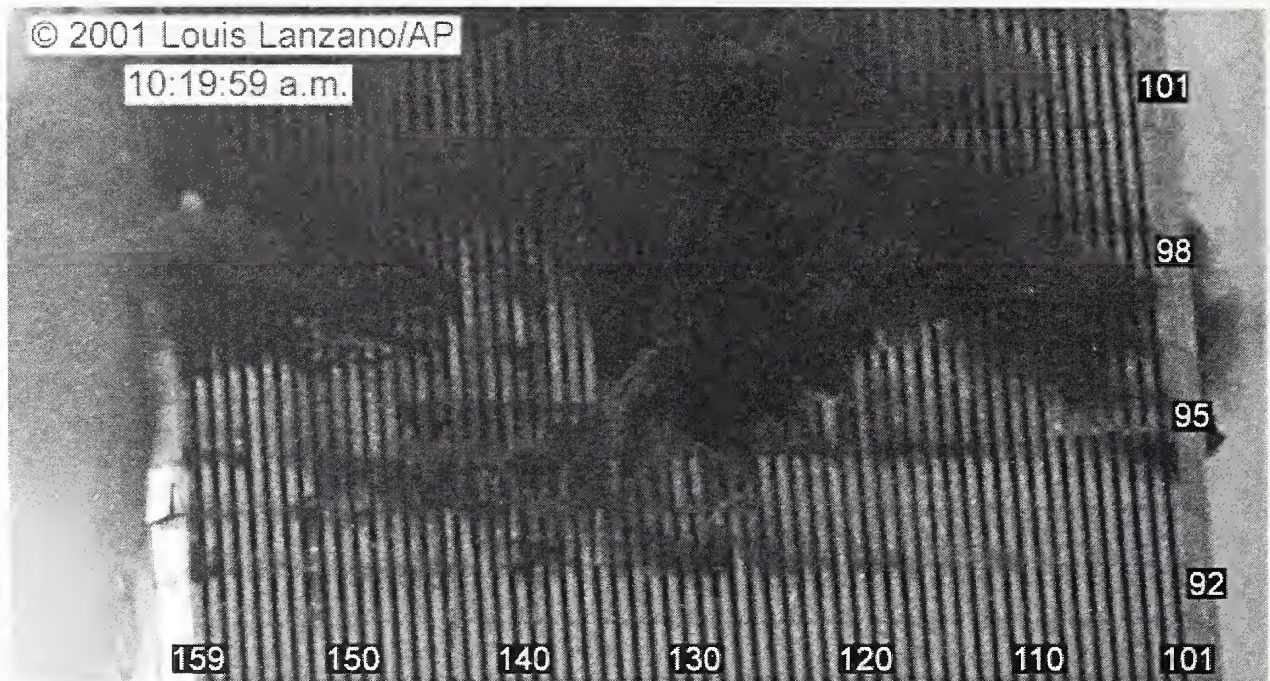
Figure 8-98 shows an image of the north face cropped from a photograph that was taken a minute later than Figure 8-96. Light smoke continues to come from the 92nd floor, where low level fires are apparent in windows 92-112 to 92-132. The fire that grew rapidly on the 95th floor immediately following the pressure pulse is still burning intensely, with flames coming from windows 95-106 and 95-107. A review of the floor plan layout for this floor in Figure B-4 shows that this fire is burning within a corner room with walls located at columns 95-456 and 95-108. Apparently, at this time the wall at column 95-108 has halted the spread of the fire toward the east. There does appear to be a fire even further to the east on this floor near window 95-115. A low level fire continues to burn on the 96th floor, with flames visible from windows 96-113 to 96-118. Heavy smoke is still flowing from windows on the 96th and 97th floors.

With the exception of the fires that grew on the 96th and 97th floors shortly after the aircraft impact, it has generally been observed that very little smoke and/or extended flames flowed from open windows on the north face where fires were visible. This has been interpreted to indicate that the smoke from these fires was venting elsewhere within the tower. The fact that smoke and fire continued to vent from the north face following the pressure pulse may be an indication that the internal ventilation pathways were changed as the result of the event responsible for the pressure pulse.

Figure 8-98. This cropped photograph shows the north face of WTC 1 at 10:19:59 a.m. The image has been enhanced by adjusting the intensity range. Column and floor numbers have been added.

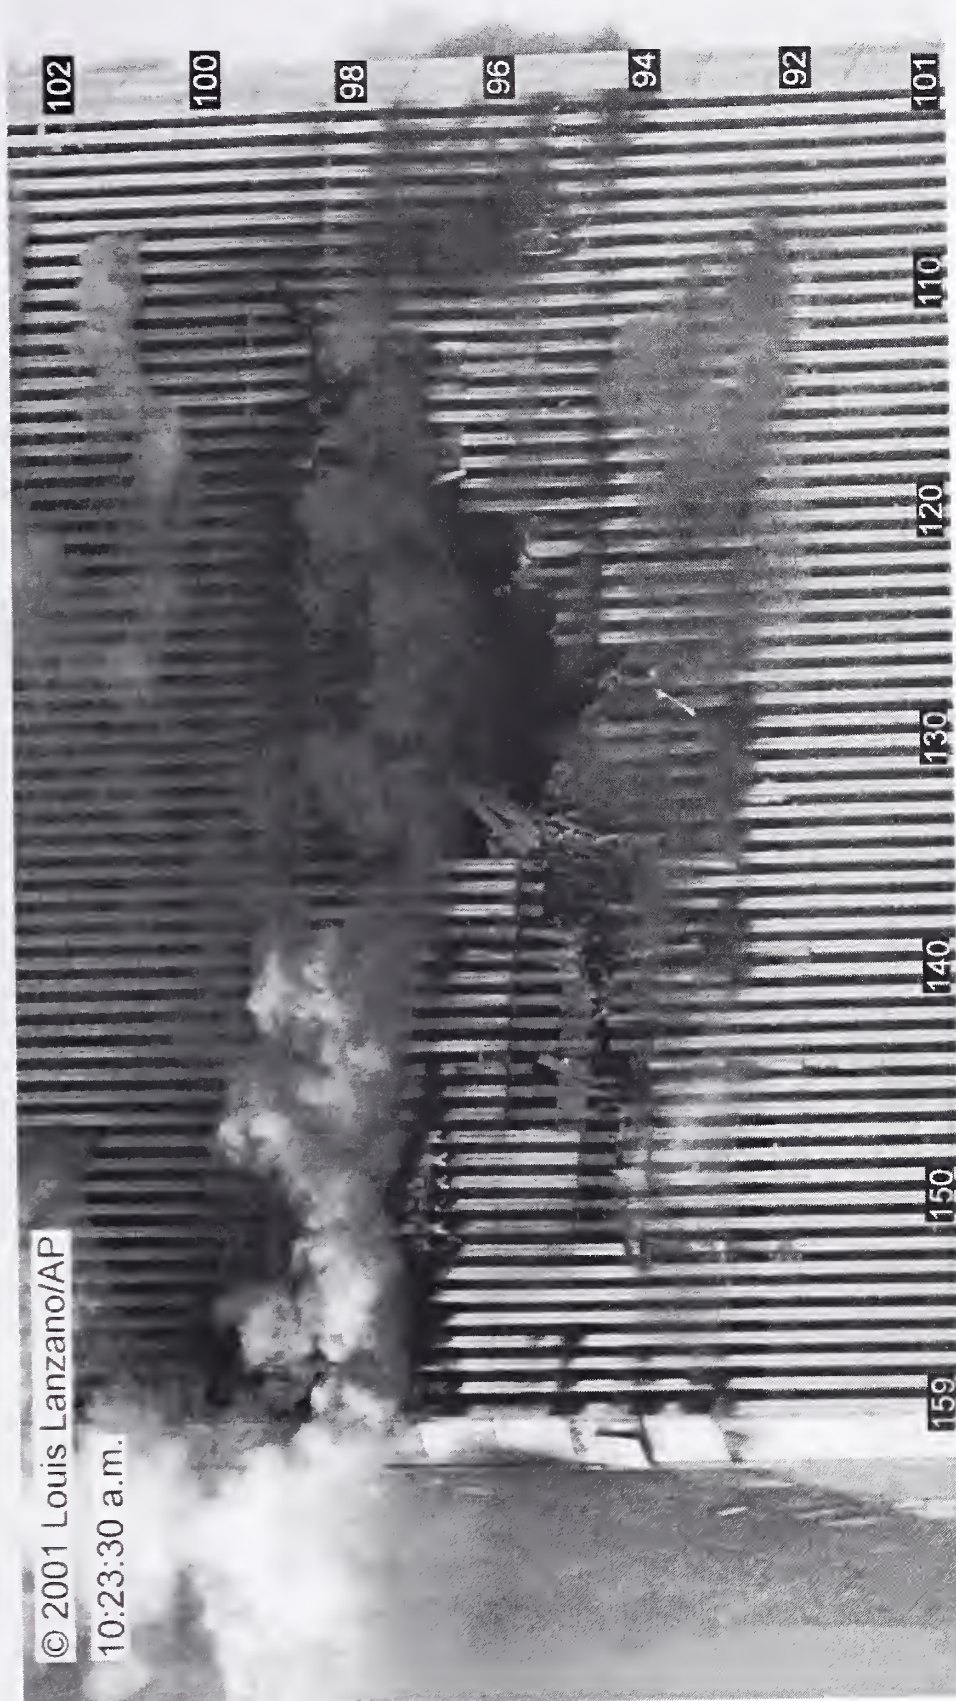
A view of the north face at 10:23:30 a.m. is shown in Figure 8-99. The fire on west side of the 92nd floor has grown dramatically since the photograph in Figure 8-98 was taken, three and a half minutes earlier. Heavy flames fill the openings from window 92-108 to window 92-114, and a nearly continuous region of flame is apparent from window 92-108 to window 92-132. The floor plan layout for the 92nd floor in Figure B-1 shows that a large open area extended along the north face between walls located at columns 92-132 and 92-105. Figure 8-99 indicates that nearly this entire area was involved in fire at this time. A small fire is evident in window 92-104, while windows 92-101 to 92-103 and window 92-105 appear to be closed. This indicates that a fire has moved into the northwest corner room with walls located at columns 92-105 and 92-455. Interestingly, in an almost identical photograph recorded five seconds earlier, the fire in window 92-104 was not visible, and all of the glass for windows in the corner room appeared to be intact. This suggests that the fire in the northwest corner room of this floor has just become large enough to break windows at this time. This close-up photograph also reveals that small spot fires continued to burn on this floor at the eastern side, where larger fires had been present earlier.

Videos reveal that the heavy fire near window 92-110 began to grow rapidly around 10:21:30 a.m. Smoke was observed coming from windows in the area somewhat earlier. In the videos the small fire present in window 92-104 is barely visible around 10:23:30 a.m. At 10:24:04 a.m. a bright flame suddenly appeared in window 92-103, and smoke was released from this window. A stream of smoke appeared from window 92-101 at 10:24:07 a.m., and an intense puff of smoke came from the same window at 10:24:21 a.m. Rapid fire growth occurred at this point, with flames clearly visible in windows 92-101 to 92-103. Apparently, flashover occurred in the northwest corner room around this time.

Figure 8-99. This cropped photograph shows the north face of WTC 1 at 10:23:30 a.m. The image has been rotated and enhanced by adjusting the intensity range. Column and floor numbers have been added.

By 10:23:30 a.m. the fire in the northwest corner room of the 95th floor had begun to die down, and the flames that were outside of windows at the time of Figure 8–98 had receded back into the building. The carets created by these external flames on the aluminum covers for columns 95-105 to 95-108 are distinct in Figure 8–99. Dull orange flames can be seen through windows 95-108 and 95-109, indicating that a fire was present on the other side of the wall located at column 95-108 (see Figure B-4). It is not clear whether the glass in these windows has broken or not. A small spot fire is also visible in window 95-115. The dying fire on the western side of the 96th floor is not visible in Figure 8–99, but small flames can be seen higher up on the 98th floor.

This area of flame on the southern side of the east face is visible in Figure 8-99, which was taken at 10:23:30 a.m. The fire is burning intensely with extended flames. Figure 8-103 shows a lower-resolution photograph taken at 10:23:41 a.m. that provides a slightly less oblique view of the east face in which it is easier to identify the flame location. The area where flames are visible coming from open windows has been highlighted. Flames can be seen on the 98th floor at two apparently separated locations. One of these is near the center of the face, and the second is well to the south. Even though the flames appear to be separated, videos and Figure 8-99 show that the flaming region was continuous over this length. A small area of fire is also visible on a lower floor. This fire is most likely on the 97th floor near the location where fire was present (near window 97-145) in Figure 8-102 at 10:18:15 a.m.

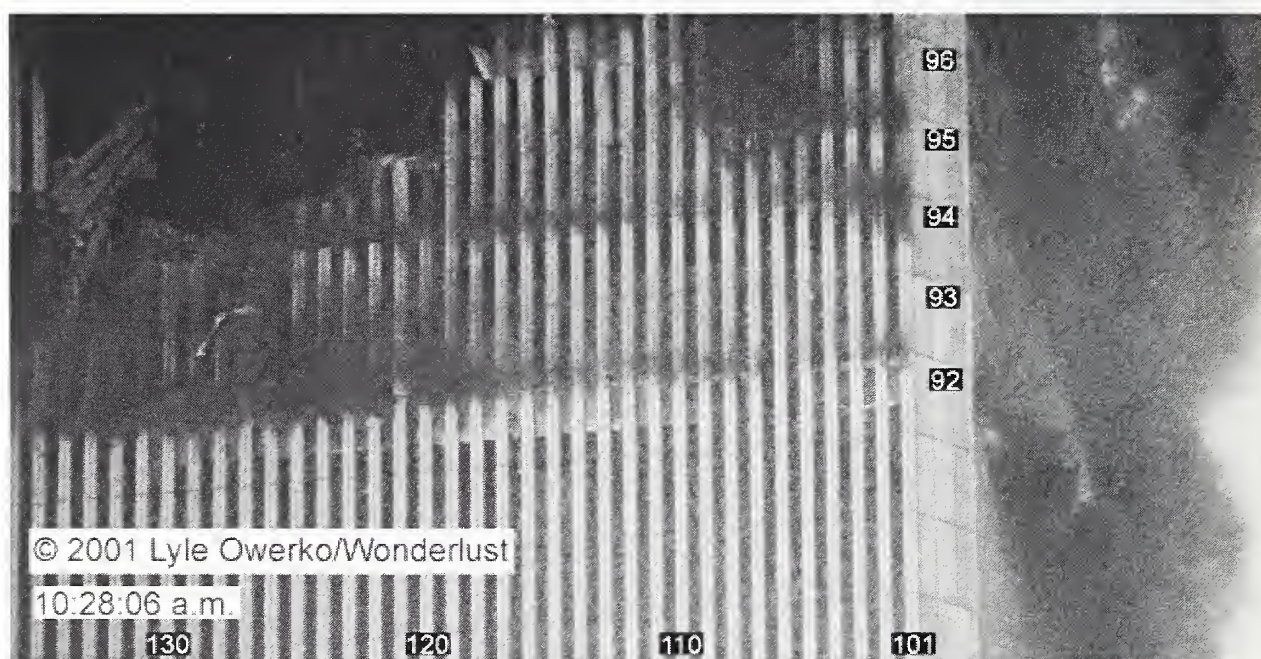
Over the next several minutes, the fire on the western half of the north side of the 92nd floor continued to grow more intense, while the other fires on the north side of the floor continued to decay. Figure 8–100 shows a photograph of a portion of the north face of WTC 1 taken at 10:28:06 a.m. This is roughly 16 s before the tower began to collapse. The large fire burning on the 92nd floor at this time is evident. Flames can also be seen on the north edge of the west face, indicating that the fire has turned the northwest corner and begun moving south on the west face.

Figure 8-100. This cropped photograph shows a portion of the north face and an oblique view of the west face for WTC 1 at 10:28:06 a.m. The intensity levels of the image have been adjusted, and column and floor number have been added.

This photograph has sufficient resolution and contrast to allow a determination of whether windows are open or intact. It appears as if three windows on the 92nd floor, windows 92-105, 92-106, and 92-120, still have glass in place. The other windows visible on this floor are open.

The photograph in Figure 8–100 was shot from a ground location relatively close to and slightly west of the tower. For this reason it may not provide as complete a view of interior fires as some of the other images shown earlier. Nonetheless, it is clear that the fires that were easily identified minutes earlier on the 95th, 96th, and 97th floors are not visible and must be burning at relatively low levels. The fact that the fire on the 92nd floor is so prominent supports this conclusion.
